ERDC/EL TR-04-10

*Dredging Operations Technical Support Program
Monitoring Completed Navigation Projects Program*

Guidance and Lessons Learned from Monitoring Completed Navigation Projects

June 2004

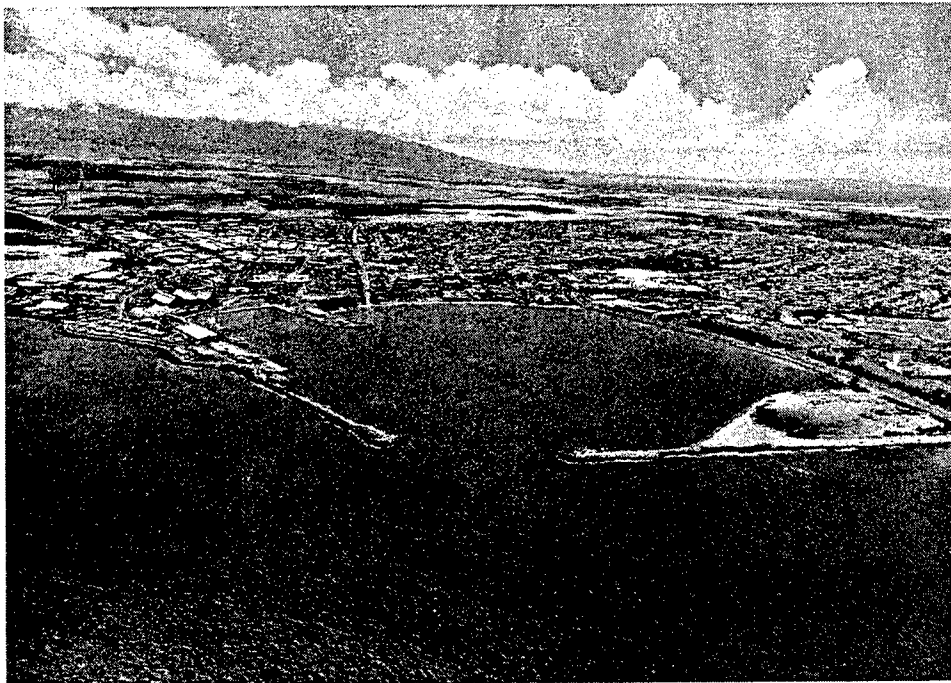
Figure 2. Kahului Harbor, Maui, HI (after Bottin and Meyers 2002b)

breakwater. An inspection in 1973 revealed that 29,965-kg (33-ton) tetrapods on the sea side of both heads had sustained considerable damage and they, along with the 7,265-kg (8-ton) stone areas on both trunks, were in need of repair.

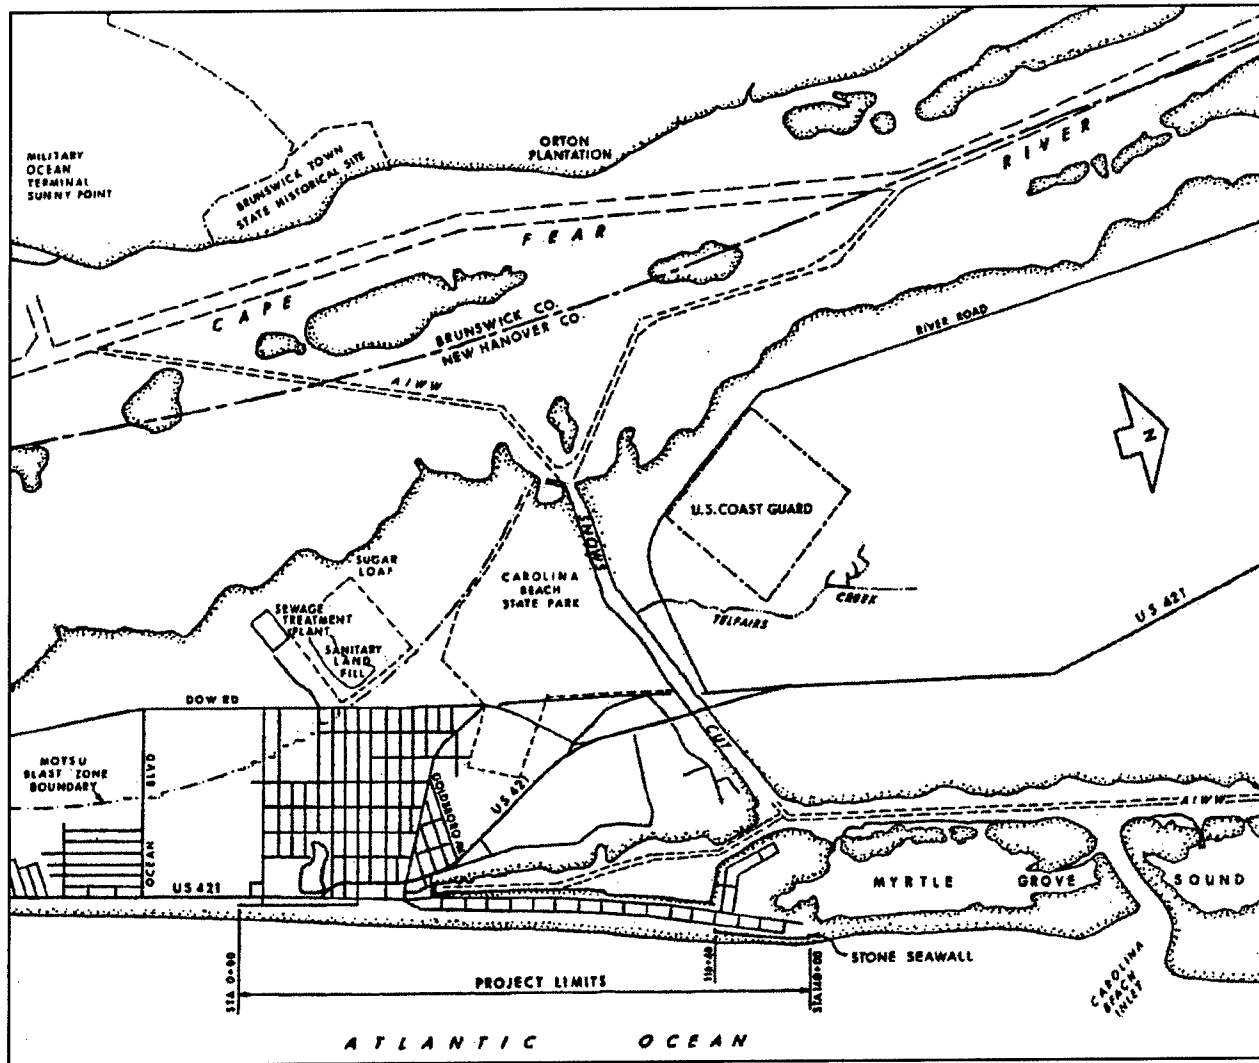
Figure 26. Carolina Beach, North Carolina (after Jarrett and Hemsley 1988)

- a.* The Carolina Beach project performed generally as expected, but experienced slightly higher volume losses than originally anticipated. Until the material in the construction berm along the southern 3,050 m (10,000 ft) of the project moves to the lower portion of the active profile, volume losses along this segment will probably continue to be high.

Eventually, the southern 3,050-m (10,000-ft) segment is expected to attain some degree of stability. Along the northern 1,220 m (4,000 ft), the sediment deficit caused by Carolina Beach Inlet remains a problem and will require a continuous renourishment program with materials obtained from the Carolina Beach Inlet sediment trap.

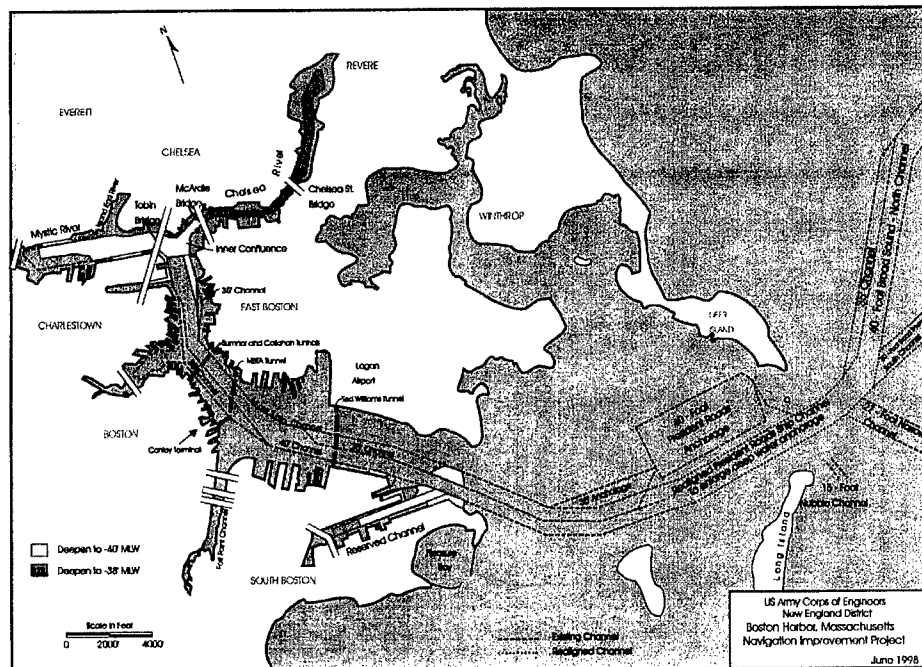
Figure 31. Boston Harbor Navigation Improvement Project, Boston, MA (after Hales 2001)

- a. Sediment resuspension and loading characteristics were studied under near-similar operating and environmental conditions for three clamshell dredge buckets: (1) Great Lakes Dredge and Dock (GLDD) Conventional (open-faced); (2) GLDD Enclosed; and (3) CableArmTM. The Enclosed bucket had the lowest overall turbidity, with substantially less in the middle of the water column. However, the District expressed concern that the enclosed buckets were adding additional water to the already soft and weak sediments, possibly causing a further reduction of the bearing capacity of the sediments.

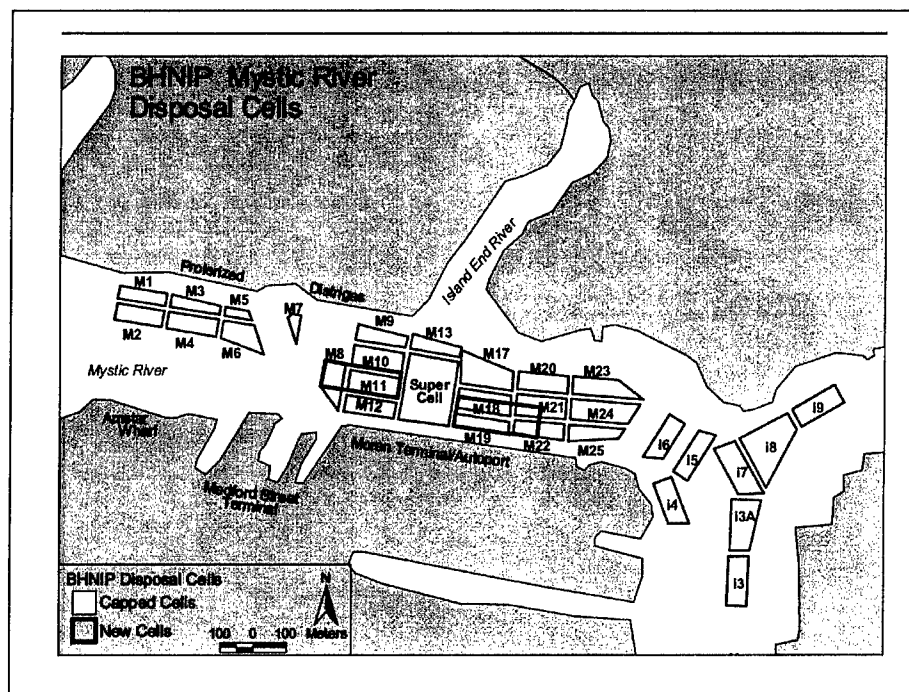
Figure 32. Confined Aquatic Disposal (CAD) cells being capped, Boston Harbor Navigation Improvement Project, Boston, MA (after Hales 2001)

- b. Grab samples and core samples indicated that: (1) natural cohesion and strength of the sediments were altered by the dredging process, resulting in sediments in the CAD cells that were unstable because of high water content and low shear strength; (2) excess pore water was released not only through the cap but also was vented through diapir structures that served to breach the caps in discrete areas; and (3) future projects should include an evaluation of the in situ strength of the material to be capped and the porosity and permeability of the CAD cell sediments.

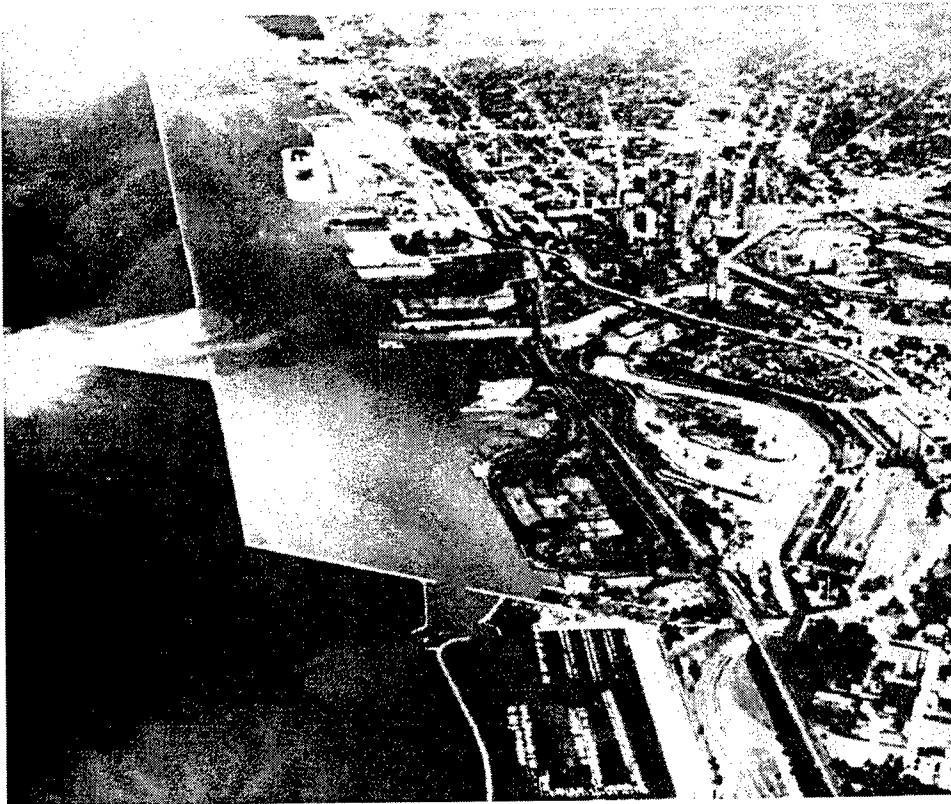
Figure 34. Cleveland Harbor, Cleveland, OH (after Pope et al. 1993)

- a. Although the 1,816-kg (2-ton) dolos-armored layer has deteriorated over the years, the breakwater continues to provide the required level of shore protection. Maintenance of the dolos cover has been on an as-needed basis. Repairs, including repositioning and/or the installation of additional armor units, are required after major storms.

- b. Wave reflection off the vertical concrete navigation light foundation at the breakwater head appears to contribute to the loss of armor units in that area. Dolos-armored units are very porous when a two-layer thickness is used. Wave energy transmits through the dolosse at Cleveland and reflects back upon them, apparently popping them out of place. Additional layers over reflective surfaces may be prudent for highly porous armor units.

- d. During the monitoring period, the 1,816-kg (2-ton) dolos cover continued to subside and lose elevation. Breakage of armor units also occurred throughout the monitoring period, but the rate of breakage appeared to decrease slightly toward the end of the monitoring period. Most breakage occurred along the waterline in the active wave zone. Little continued breakage was noted below the waterline during diving inspections.

- h. Since dolos breakage can jeopardize the structure's integrity, dolosse should be designed for "no-rocking" criteria to minimize breakage resulting from movement. Consideration also should be given to reinforcement of dolosse in the active wave zone for a deepwater structure, since breakage appears to be concentrated in this area. In addition, dolosse should be placed over a stone underlayer rather than against a flat surface to prevent movement caused by wave reflection.

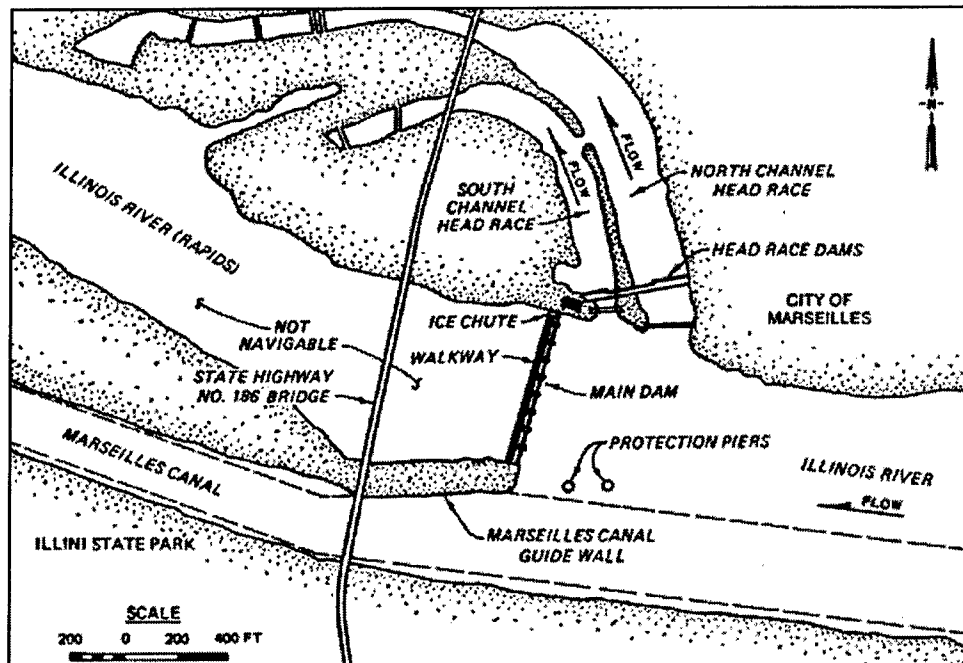
Figure 38. Marseilles Dam, Illinois River, IL (after Cooper et al. 2001)

Advantages of submersible gates are the capability of skimming loose ice with a minimum amount of flow and avoiding downstream scour often associated with large underflow gate openings at low tailwater. Also, submerged operation largely avoids the problem of freezing-in of side seals. Vibration of gates has been reported at some of the 33.5-m- (110-ft-) wide submergible gates on the

Ohio River. On some of these projects, a retrofit to a sharp-crested bottom seal eliminated the problem, but at other projects, the submerged mode of operation was discontinued.
